PLANNING, DESIGN AND SUCCESSFULLY EXECUTING 4M M3 OF DREDGING AND DRY EXCAVATION TO EXPAND PSA PANAMA'S CONTAINER TERMINAL

ABSTRACT

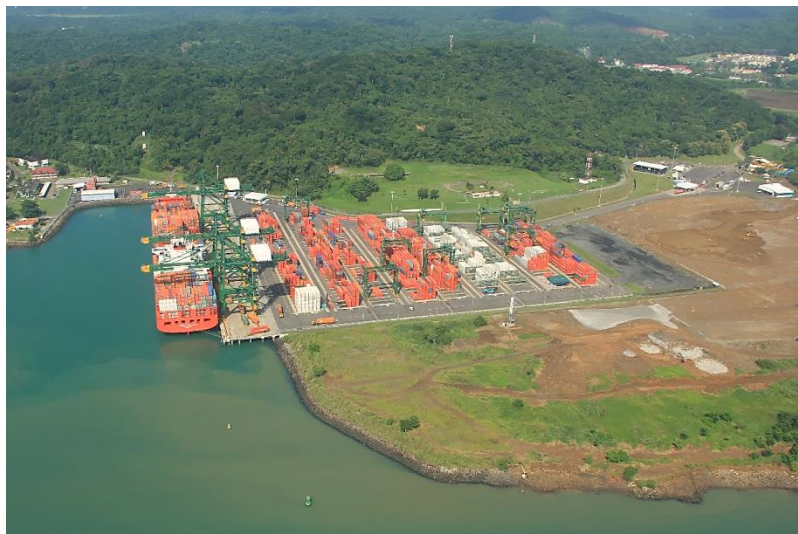
Figure 2: Completed PPIT Phase 1 Terminal

Figure 2 shows the operating Phase 1 terminal, with a large container vessel on the berth and well-utilized container storage yard. The administration building, gate complex, and equipment workshop are in the right-hand corner and clearance has started for the Phase 2 construction area.

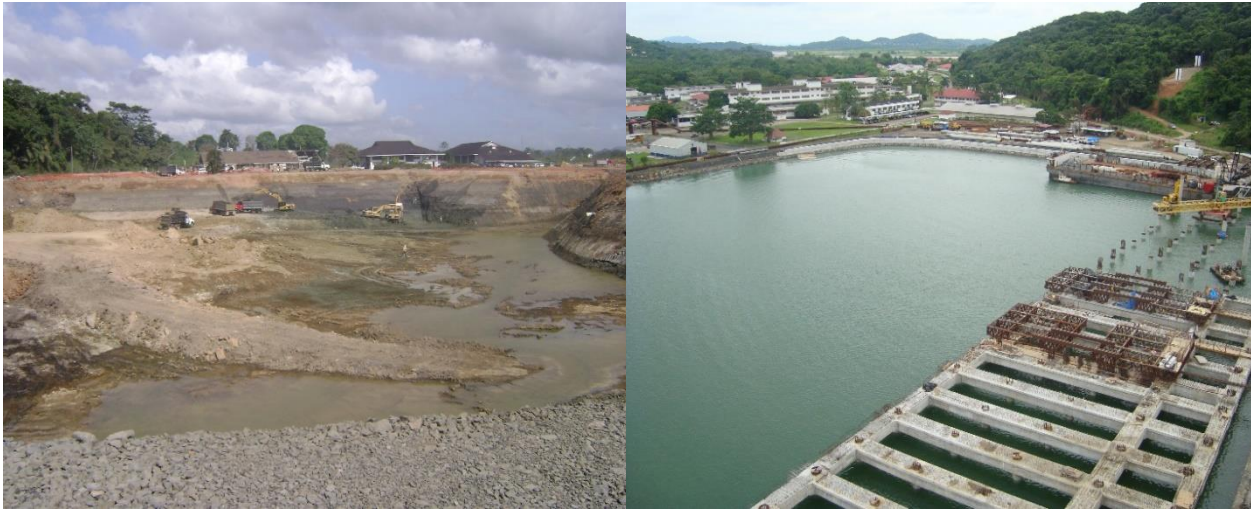
Figure 3: Phase 1 Quay Deck Construction

Construction of the quay deck was carried out partially in the dry, with the rock slope at the rear of the quay wall being constructed in a bunded area. Figure 3 shows the initial excavation of the slope at the rear of the quay deck, together with a later photo showing the ongoing quay deck construction, including piling operations, placing of the grillage of concrete beams to tie the piles together. Figure 4 shows further construction photos during the piling and quay deck construction.

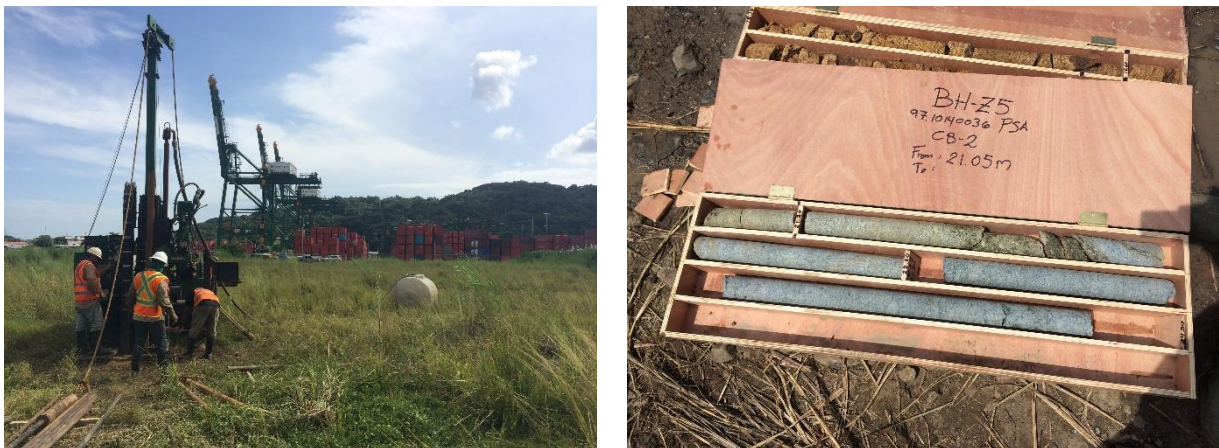
Figure 8: Borehole Drilling and Typical Core Box

Figure 8 shows a borehole being drilled at the south end of the site and a photo of a core box of mainly basalt with almost a full core recovery indicating the material to have little or no faults or fissures.

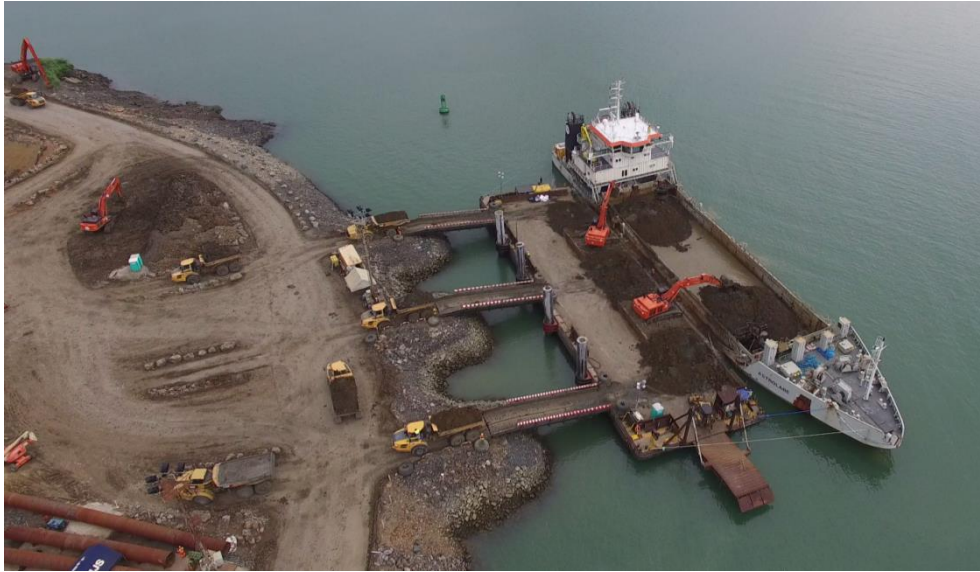
Figure 9: Temporary loading facility for off-shore disposal

All excavated material, be it in dry or dredged, was to be transported to and disposed at an authorized off-shore disposal area at approximately 20km from the site. In order to do so, a temporary loading facility was designed and constructed, consisting of a flat top barge fitted with four mooring pile collards and hinges for connecting loading ramps (see Figure 9). The collards ensured proper securing of the pontoon to four temporary concrete mooring piles that were casted up to rock layer. This floating jetty was a solid solution for coping with the high tidal differences at the Pacific side (5m) and the large layer of Pacific Muck that made other alternatives less favorable (e.g. sheet piles). The floating jetty was connected by means of three loading ramps to the shore and equipped with fenders on sea side for mooring a self-propelled split-hopper barge with a hopper volume of 3.700m³. Two large excavators in a fixed elevated position would load the material that was brought to the jetty by means of articulated dumpers into the hopper barge.

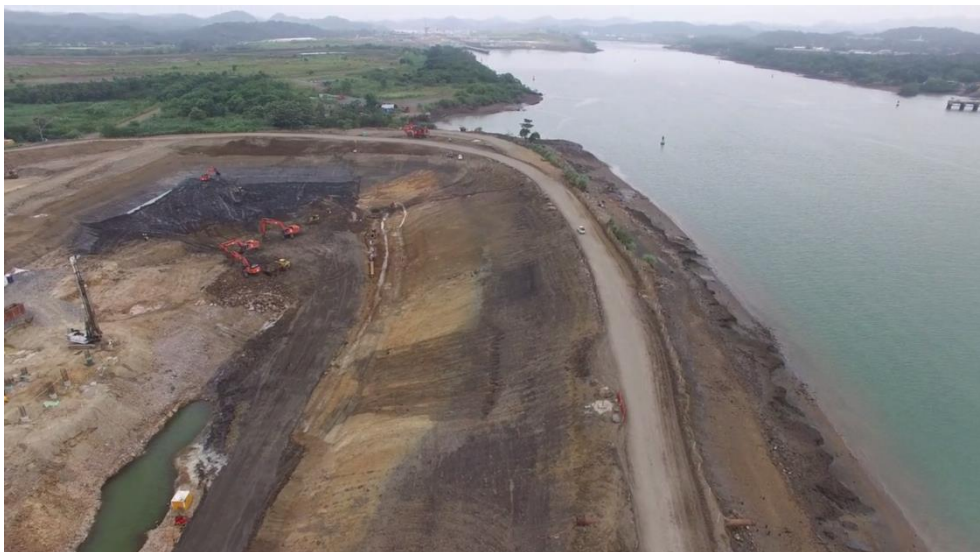
Figure 10: Dry excavation works

Each row of piles required a working platform at a different elevation and so the excavation of the pit (see Figure 10) was done in different phases and in close coordination with the piling works. Close to the first row of piles, dry excavation was done up to final design to avoid future dredging very close to the quay structure.

An access ramp was maintained at all times haul material to the temporary loading jetty. The biggest challenge was excavation and hauling of Pacific Muck in rainy weather conditions. As an optimization, when reaching below residual soil, weathered and blasted rock was recycled on site as general fill.

During the excavation works, the condition of the temporary dike was monitored periodically using inclinometers and drone footage to verify soil condition assumptions made when designing the dike and to detect anomalies such as erosion (piping) of a sand layer around 0m MLWS level.

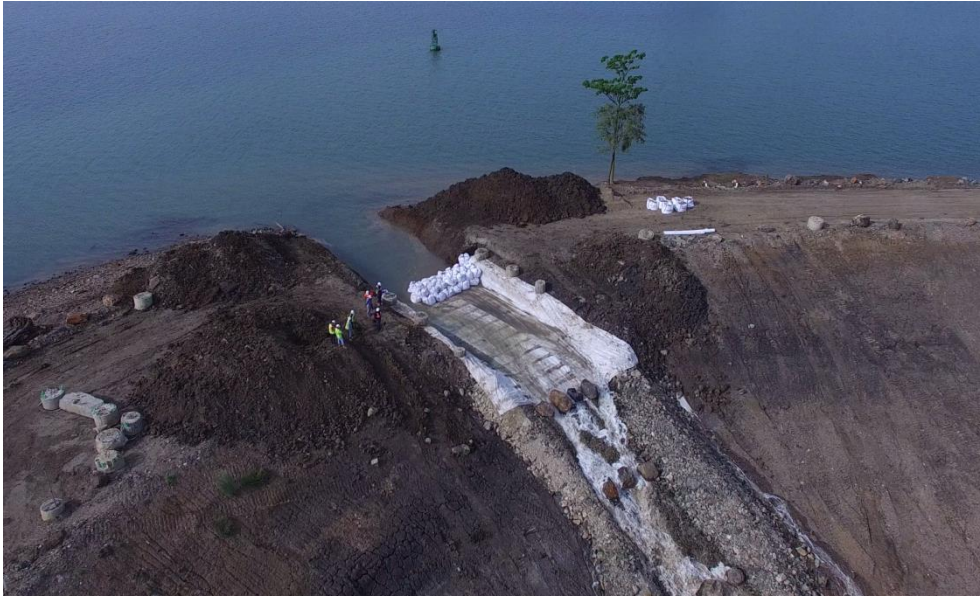
Figure 11: Controlled start of flooding

The last activity before start of the dredging works was the flooding of the dry excavation pit once excavation, piling and rock works in the main section of the quay were finished. The flooding process was designed to be slow and controlled at the beginning and to faster once blasting of the unforeseen basalt outcrop underneath the dike was finished (see Figures 11 and 12)

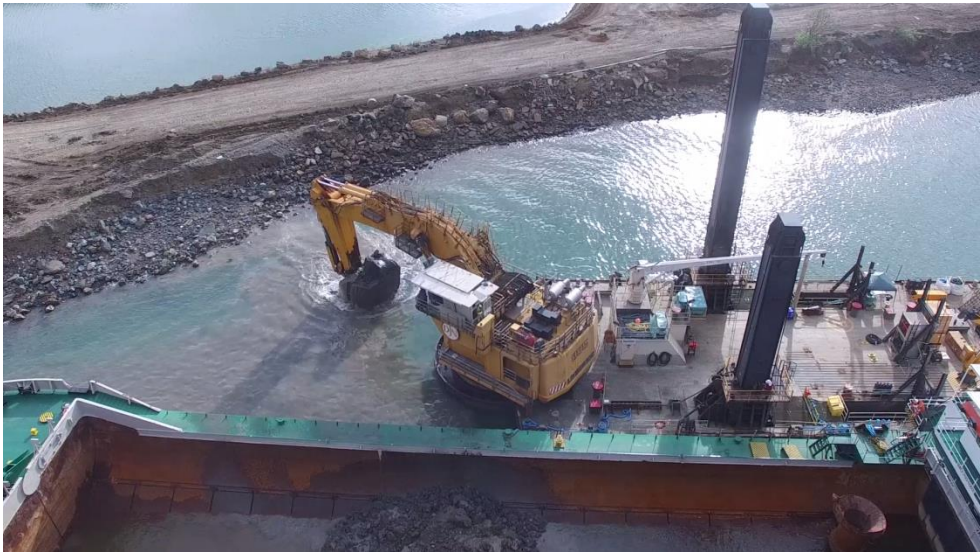
Figure 13: Dredging of loose upper layer with backhoe dredge

The backhoe dredge was used for removal of the soft upper layer of the dike (see Figure 13), for dredging in between the piles at the northern and the southern closing section of the dike and for dredging a trench in front of the first pile row wherever this was not done during dry excavation phase.
