CORROSION EVALUATION WITH MEASUREMENTS OF MARITIME STEEL STRUCTURES IN COSTA RICA

This paper considers three study cases, located in the Pacific of Costa Rica, with after construction evaluation or follow up of maritime structures, including thicknesses of steel elements and electrical potential measures of cathodic protection systems. These cases are a) A Cellular Cofferdam Breakwater at Quepos, b) A Sheet-pile wall at Caldera Port and c) A Trestle at Punta Morales Pier.

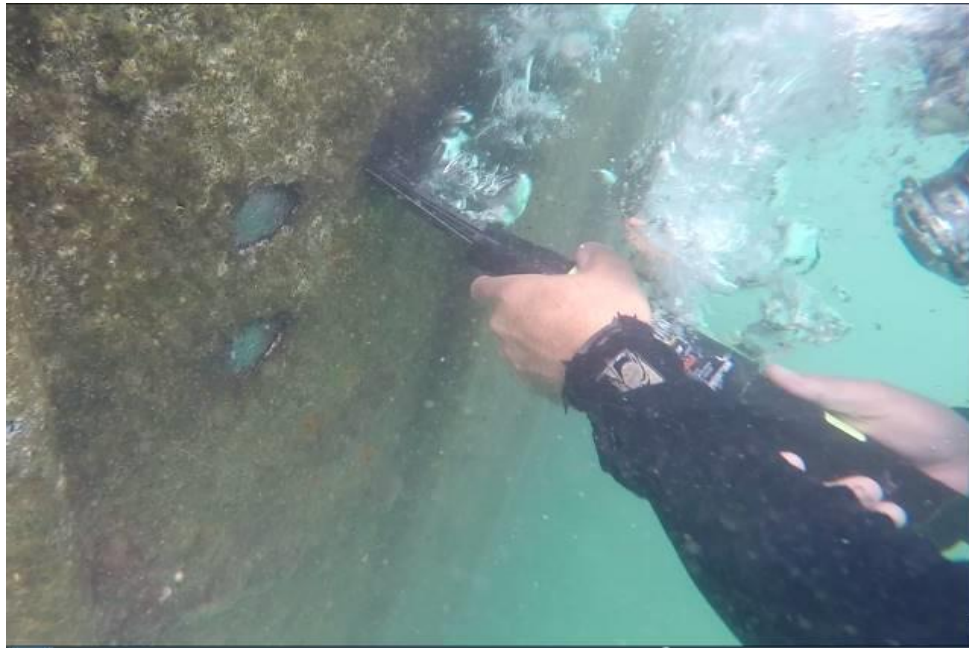
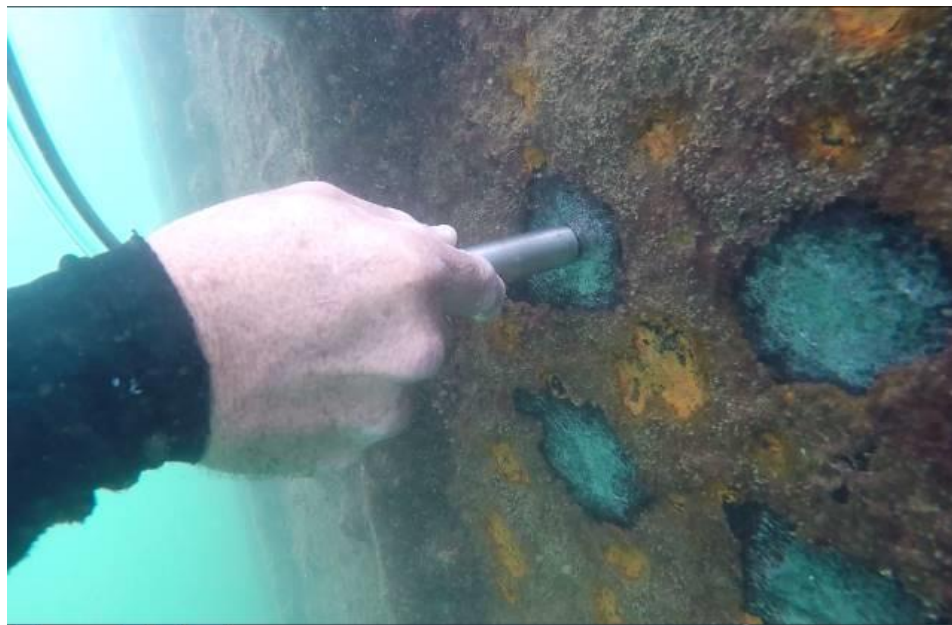
An air needle powered by a compressor was used at each measurement point to clean the sheet-pile surface from marine life and corrosion. The cleaning was done in a circle with no more than 10 cm in diameter. This cleaning was executed also above water, likewise with the same equipment.

The thickness measurements were made with a UT (ultrasonic equipment), having a nominal frequency of 5 MHz, and a straight ½ in. diameter underwater transducer, with a 15 m in cable, so that the measuring device was at the upper part of the cell all time. *Fig. 3* shows the cleaning and the installation of the underwater transducer at the surface during the measurement of one of the points.

Fig. 3 Underwater Procedures at the Marina in Quepos (Above) Cleaning of measurement points (Below) Thicknesses measurement with ultrasonic sensor.

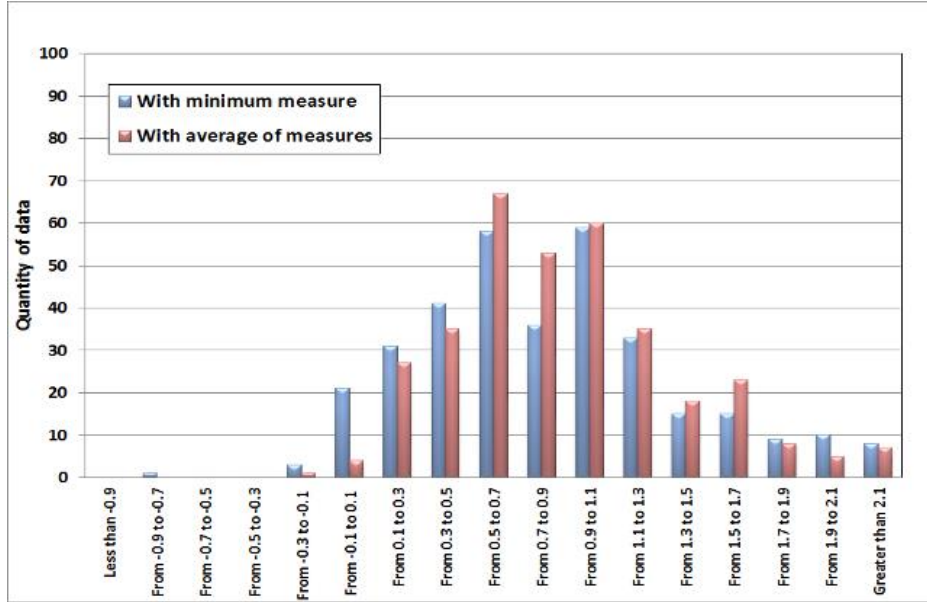
Besides the general comparison, differences between data of the same measurement points from 2012 and 2016, were calculated. For the same point, the average differences are from 0.46 to 1.10 mm and maximum from 1.22 to 2.61 mm. Those differences are summarized on *Fig. 7*.

Fig. 7 Thicknesses differences of measurements, 2016-2012.

As shown, few measurements were higher in 2016 compared with the ones from 2012. That may be due to differences in equipment or cleaning, but also because, by procedure, measurements are directly on site, which never happens in the same exact spot. This is, for each measurement, an area of the sheet pile surface about 10 cm diameter, is cleaned, and the transducer is placed within this area. As the surface is irregular, some differences between measurements from different years are expected central cells.

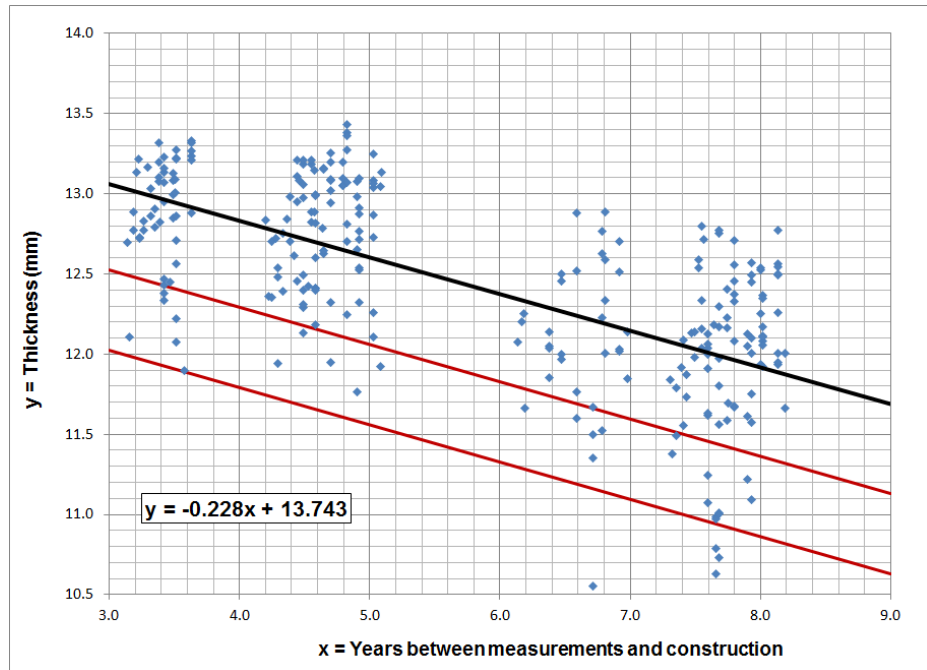
Fig. 8 Adjustment lines for the north breakwater outside and above waterline, 2012 to 2016.

Linear best fit lines were determined, with the measurements from 2012 to 2016 as part of the same set of data. For considering lower limits for the best fits, two other parallel lines to the fit line were included with a separation between them of 0.5 mm. *Fig. 8* shows the data and adjustment lines for the inside section of the north breakwater. The same was done for other combinations north-south breakwater, inside-outside sections and over-under water.

These comparisons are intended to consider the general behavior of the breakwater. Low correlations are expected, as they include different levels and locations along breakwaters, where individual corrosion rates are not the same. The slope of the adjustment lines can be considered as an average corrosion rate of the structure section. In the case, for the external north breakwater above the water, it is 0.23 mm/year, which is high, but expected for tropics with no barrier or cathodic protection.

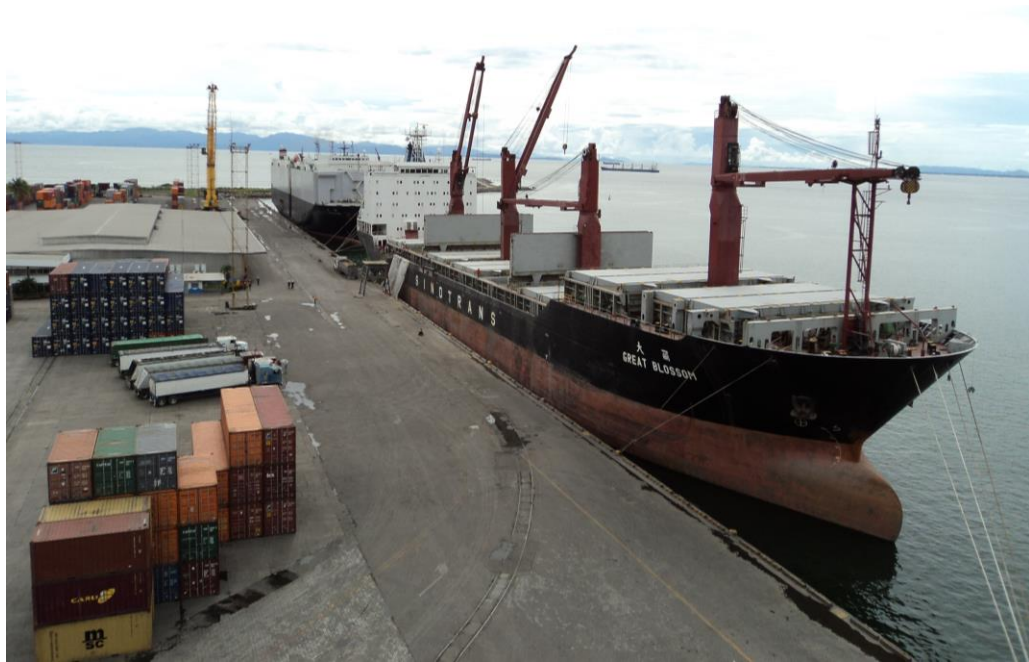
The principal bulkhead of Port of Caldera, includes three berthing positions Berth N.1-N.3 depths from -7.5 to -11 m LWL with a total length of 500 m, and was constructed in 1980 i.e. have 38 years of service (Fig. 11). An additional Berth N.4, which starts operation in 2014, corresponds to a pile supported pier, and is not included in this analysis.

Fig. 11 Quay wall at Puerto Caldera, taken from the end of Berth N.3.

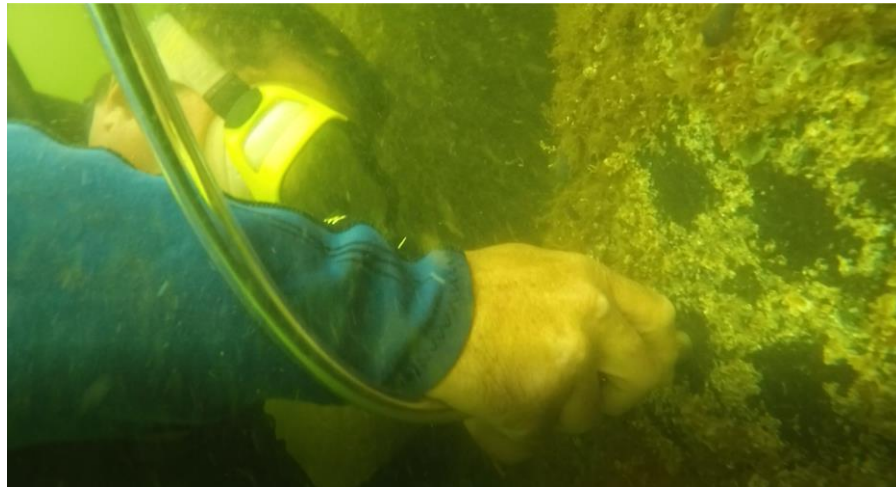
Steel thicknesses measures, follows an analogous methodology as in the previous case study, with the difference that only measurements below water were executed, where there is no concrete cap. (Fig. 13) Since the measurements from 2011, were taken as a base, longitudinal measurements were performed that year on sections every 10 meters. Based on the information from the campaigns of 2003 and 2011, follow up thicknesses measurements for following campaigns were executed at 8 control chosen sections.

Fig. 13 Example of thickness measurement at Caldera sheet-pile wall, 2017.

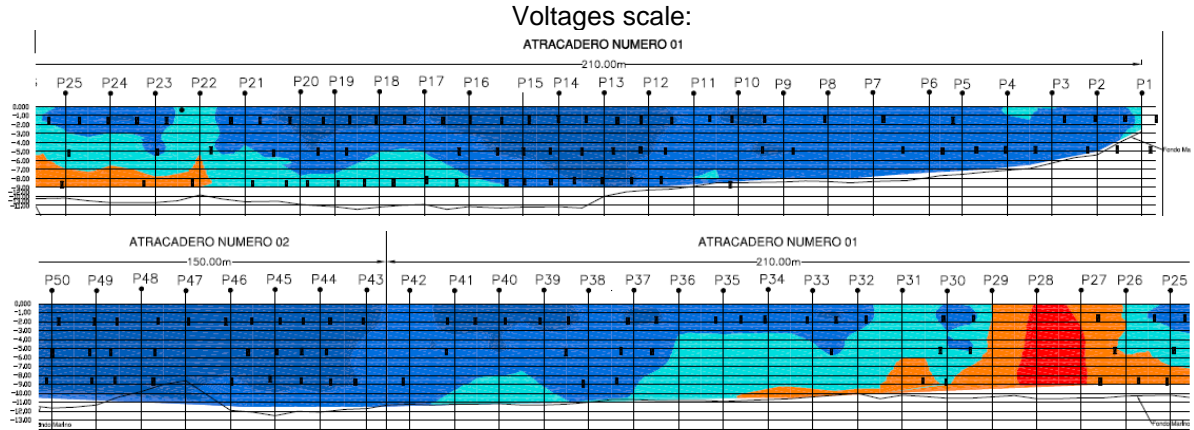
As indicated before, the measurements of the voltages generated by the cathodic system, could be used to evaluate the provided protection to the sheet-pile. The campaign from 2011, is interesting since, the locations of the existing anodes were surveyed. When these locations are compared with the interpolation of the potential through the wall, it could be seen that the variations of the voltages ranges are related to the anodes location (*Fig. 15*). For example, an area outside specification was detected at middle of Berth 1, which is due to the lack of sacrificial anodes in the area.

Fig. 15 Potential distribution and location of anodes in the sheet-pile wall on berth N.1, 2011.

If the potential is not what is required, additional anodes are welded to regain it. Also, after the new anodes were installed, electrical measurements are performed to confirm the protection. This approach minimizes maintenance costs since only the sections that need anodes would be re-protected with them, compared to replace anodes after certain mass loss despite the generated potential.

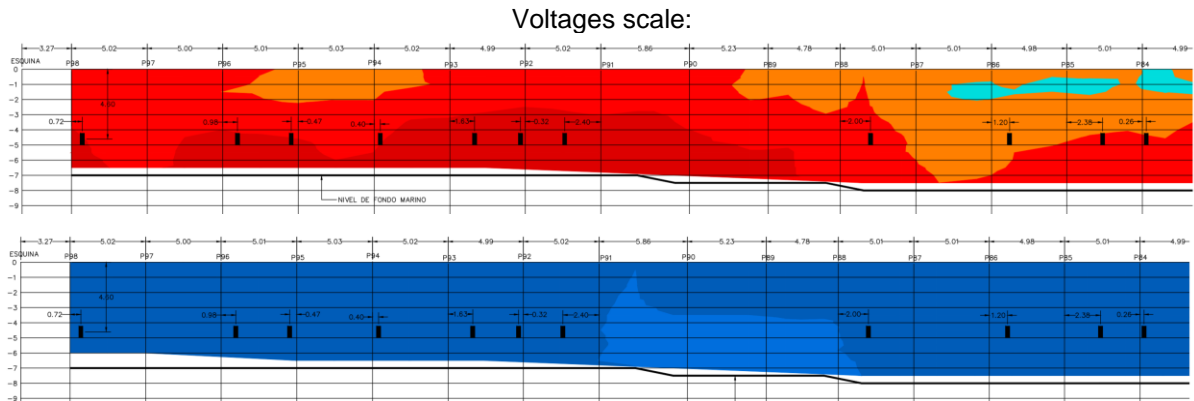
There had been other cases in which this happened. One was after the construction in 2012 of the underwater rock revetment at the Berth 3 corner, which was required for the slope protection between this corner and the dredging Berth 4. Because of the construction method for rock layers conformation, most of the anodes from the wall were ripped and potential measurements became inadequate.

Fig. 16 Potential voltage measurements at a portion of Berth N.3 (Above) Before installation of anodes. (Below) After installation.

After la installation of only 21 anodes in the bottom of the wall, the potential was regained. These could be seen in on *Fig. 16* for a portion of Berth N.3, with the location of the new anodes for more clarity. Above and below graphs are the conditions before and after the installation of the new anodes.

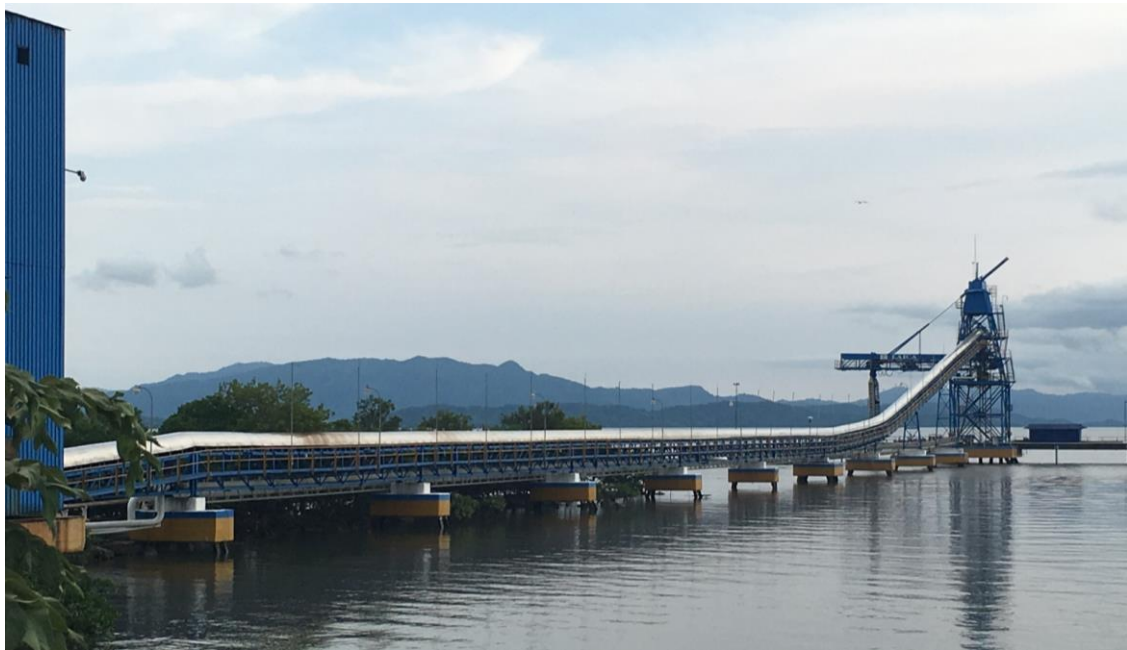
Fig. 17 Punta Morales Pier (Above) Layout of the pier including Charging Platform, Berthing Dolphins and Conveyor supports (Below) General View of Trestle Supports from land.

The Punta Morales pier, principally for sugar export, was constructed in 1980, and is a dolphin-type pier with a loading platform, all steel pipe piles. The sugar is transported from a warehouse on land to the loading platform by means of a conveyor belt. This belt is supported on (9) concrete caps, each one with (4) H-beam steel piles. In general, the piles were located with a certain horizontal inclination with respect to the axis of the conveyor belt, although the majority are with the flanges oriented in the direction of the belt axis. The layout of the pier including the conveyor support is shown on Fig. 17.

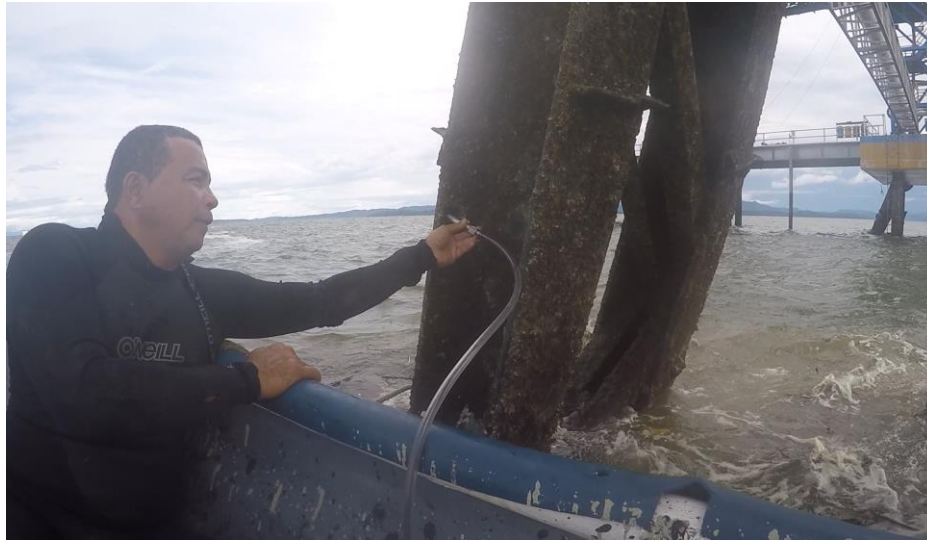
Due to visibility issues, it was not possible to reach the first of the supports from the ground to the seabed, but up to the level -7 m NMBS, which is about 2 meters above sea-bottom. In all other supports, measurements were made to the seabed. *Fig. 19* shows a thickness measurement in one of the piles on the first support from the pier.

Fig. 19 Thickness measurement in one pile of the first support from the pier

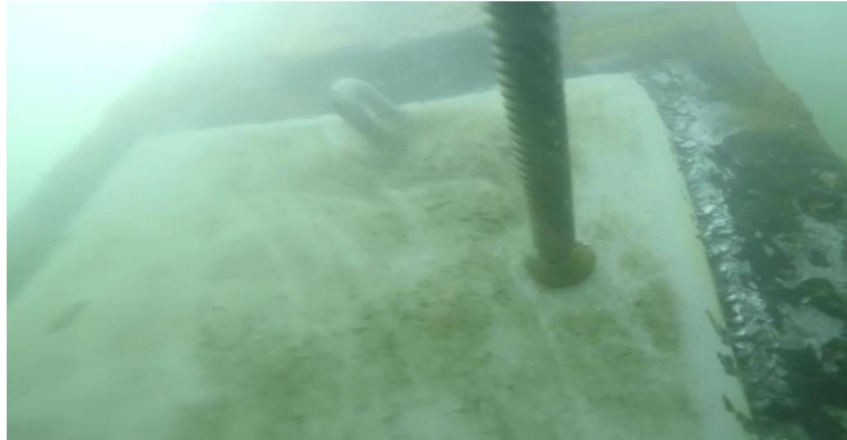
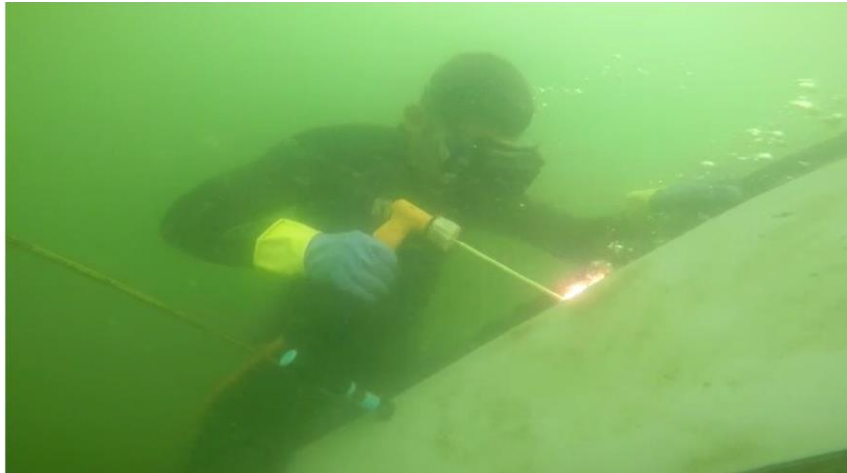
Fig. 21 Procedure for reinforcement of H-piles (Above) Installation of plates (Center) Underwater welding of plates (Below) Underwater coating of welds and plates borders.

For additional protection, plates were painted with marine coating before installation, and the pile surface, where a plate goes, was cleaned from maritime life and corrosion, manually and using pneumatic tools.

Plates were placed in the intended position, secured and welded. Once the reinforcement plates were welded, the welds were toughly cleaned from slag, and from incipient marine life and corrosion. The borders of the plates were protected by a coat that could be placed and cured below underwater. This operation was performed once the welding was finished, which justifies the additional cleaning before coating. *Fig. 21* shows the general procedure of installation of reinforcement plates underwater.
